### **Characterization of Reactants**

**MGPI Processing Inc. in Atchison Kansas**

**CASE File No: 2445003**

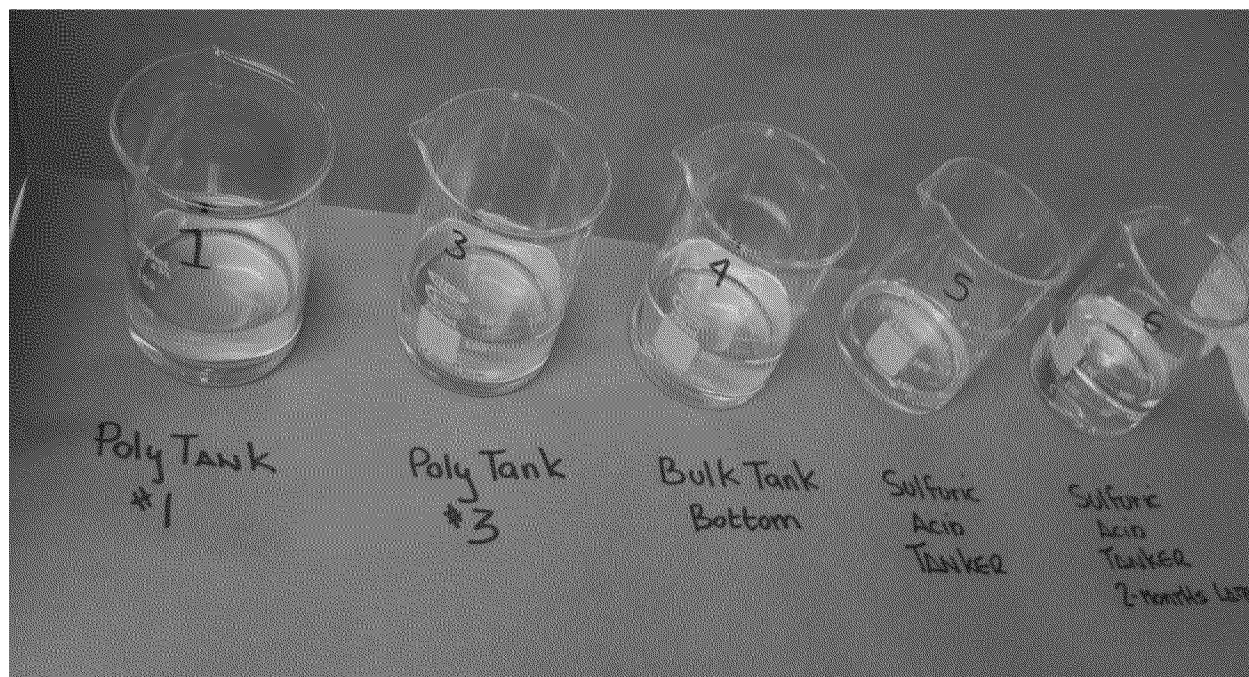
**Photograph 1**  
The photograph shows sub-samples of the subject samples.

Interpretation of the data shown in Table 3 is itemized below. Photos of the sample are shown in Photographs 1-3.

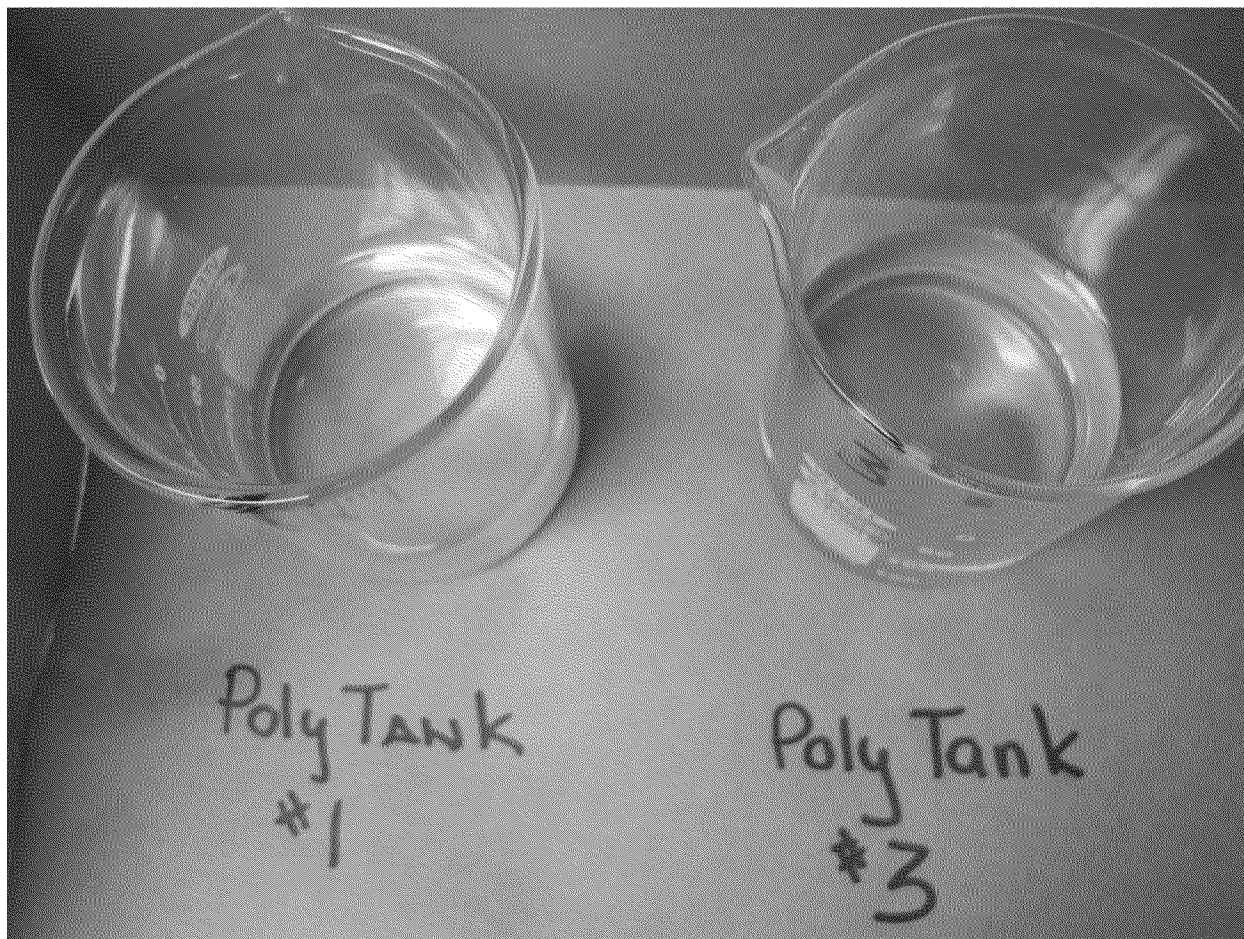
**Photograph 3**  
The photograph shows sub-samples of the subject samples
